Corrosion Control of Central Vehicle Wash Facility Pump Components Using Alternative Alloy Coatings

Final Report on Project F09-AR14

Michael K. McInerney and Robert B. Mason, Jr.

July 2016

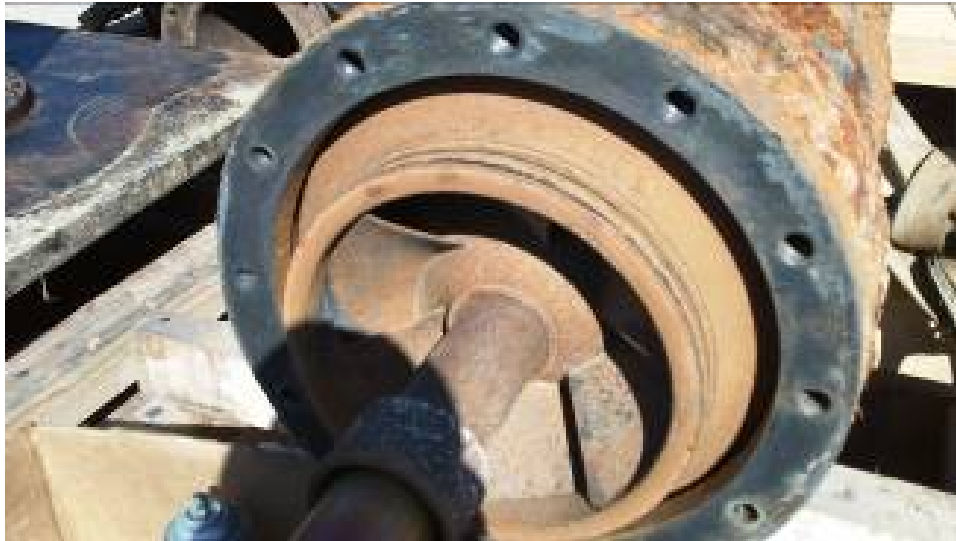
Figure 11. Old Unit 1 first-stage impeller.

The old Unit 1 pump was cut to expose the fifth-stage (top) impeller, which showed some signs of erosion and wear. The impeller was removed, and

then the lower cap of the first stage was removed to expose the intake side of the impeller, as seen in Figure 11.

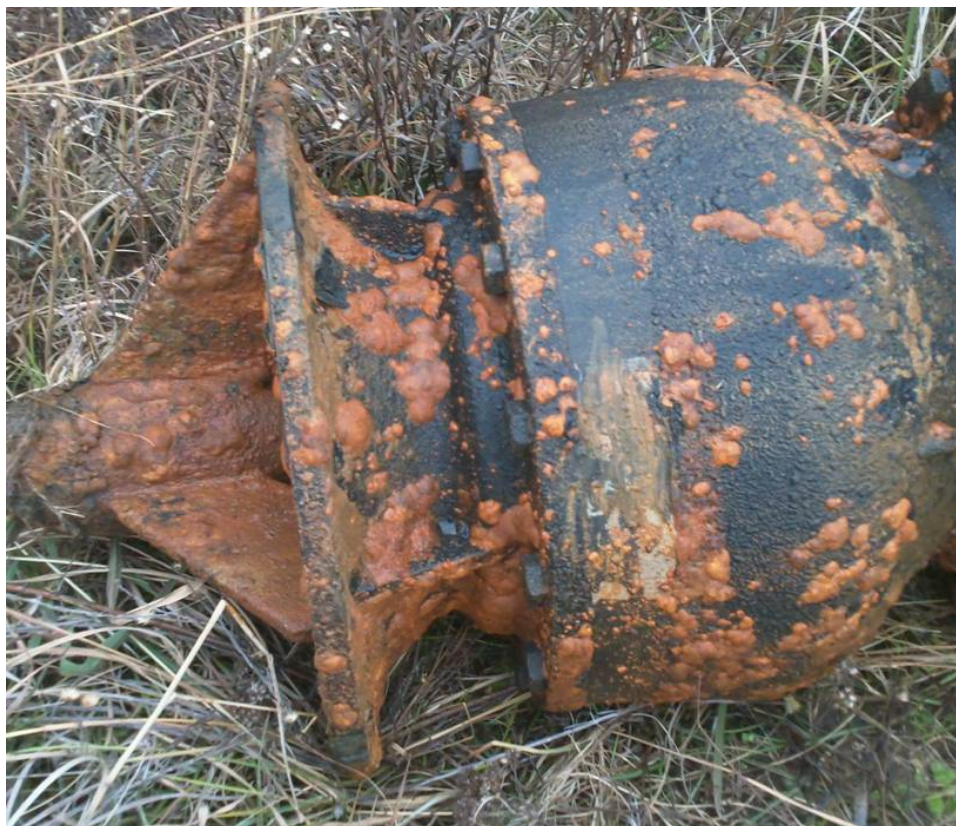
Figure 14. Condition of first state of old Unit 2 pump.

The Unit 2 pump was evaluated first since it was the first to be disconnected and removed. All of the outer pump surfaces were found to be severely corroded. However, the steel was not perforated at any point, indicating that the corrosion was general rather than localized. The condition of the first stage of Unit 2 pump is shown in Figure 14.

Since more than 50% of the outer surfaces of the pump were corroded, all surfaces were given a rating of “0” for both protection and appearance in accordance with ASTM B537. Even the basket at the bottom of the first stage was severely corroded.

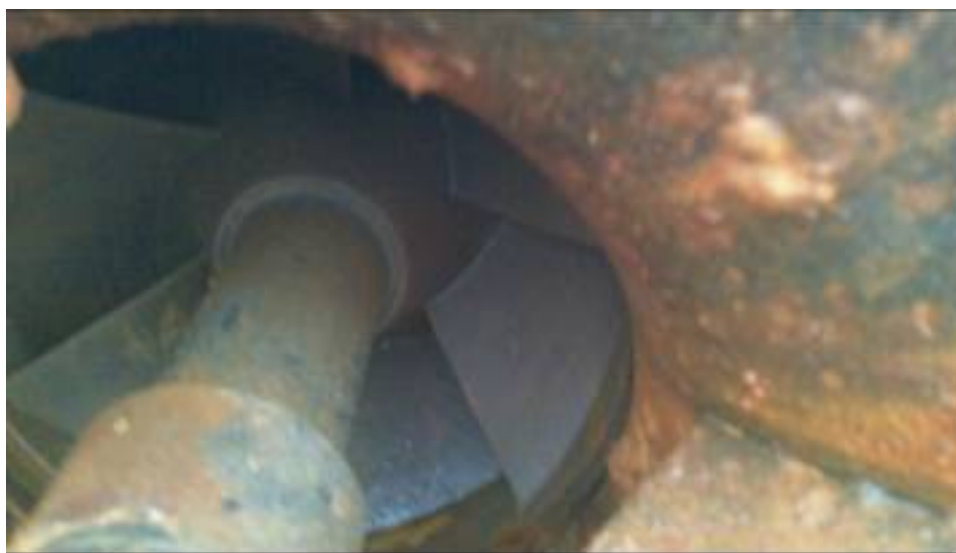
Figure 15. Old Unit 2 pump first-stage impeller.

Despite the corroded appearance of the outer surfaces, the impellers from this pump were found to have minimal corrosion or erosion. Only very minor wear was observed. The condition of the first-stage impeller from this pump is presented in Figure 15.

The condition of the impeller corresponds to a rating of 9 in accordance with ASTM D2809.

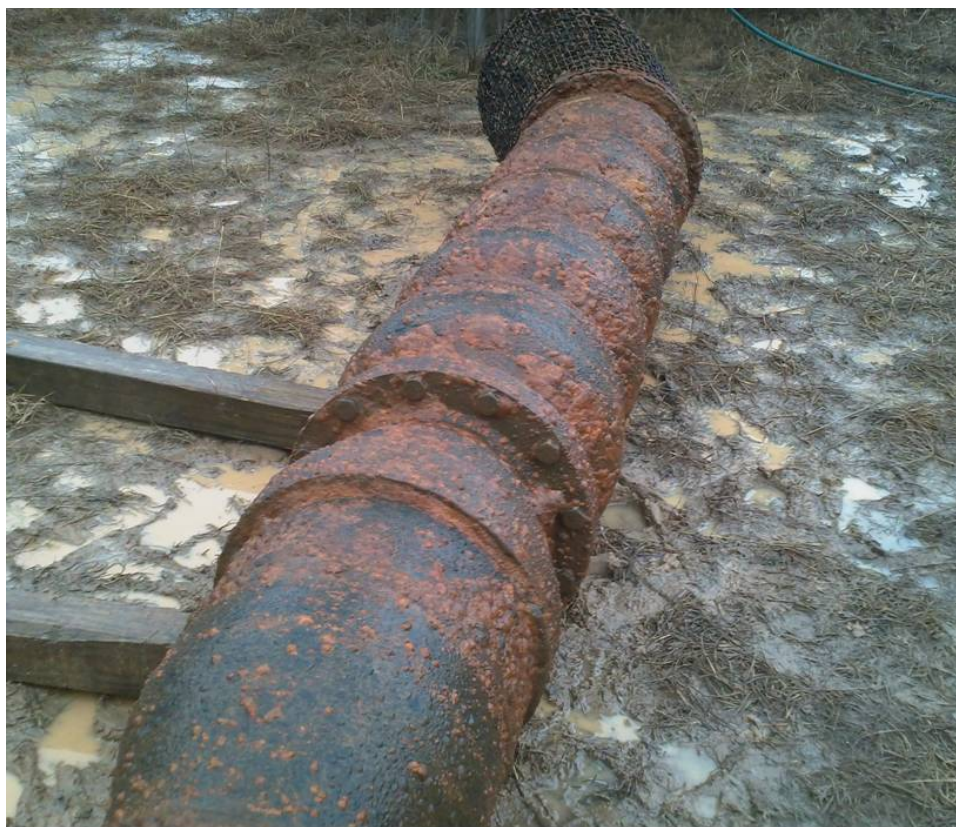
Figure 16. Condition of old Unit 1 pump bowls.

The Unit 1 pump was also found to be severely corroded when removed from the sump. Once again, no perforation of the outer surfaces was observed. The exterior condition of the bowls from the Unit 1 pump is shown in Figure 16.

Since more than 50% of the outer surfaces of the pump were corroded, all surfaces were given a rating of “0” for both protection and appearance in accordance with ASTM B537.

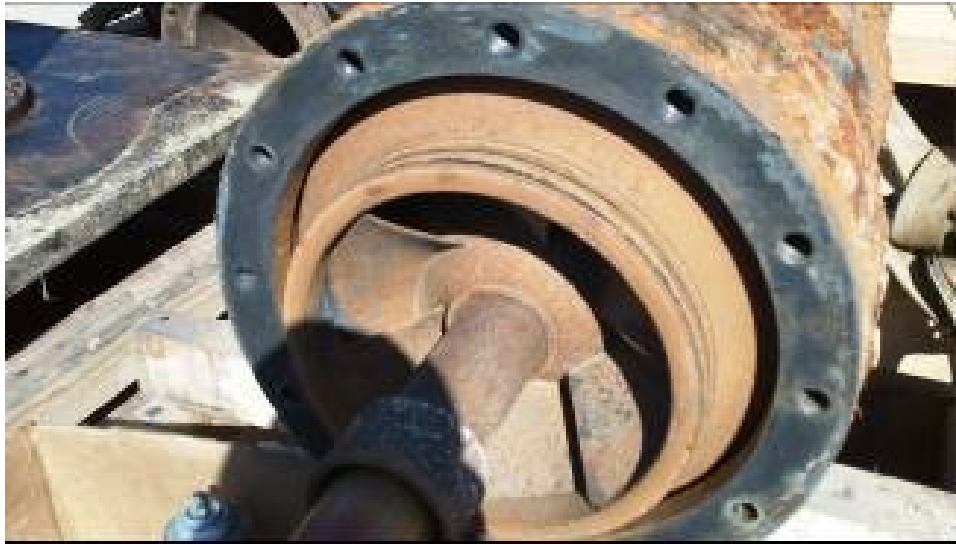
Figure 17. Old Unit 1 first-stage impeller.

The impeller from this pump displayed some evidence of erosion. The condition of the first- and fifth-stage impellers from the old Unit 1 pump is presented in Figure 17 and Figure 18.

The condition of the first-stage impeller corresponds to a rating of 4 in accordance with ASTM D2809.

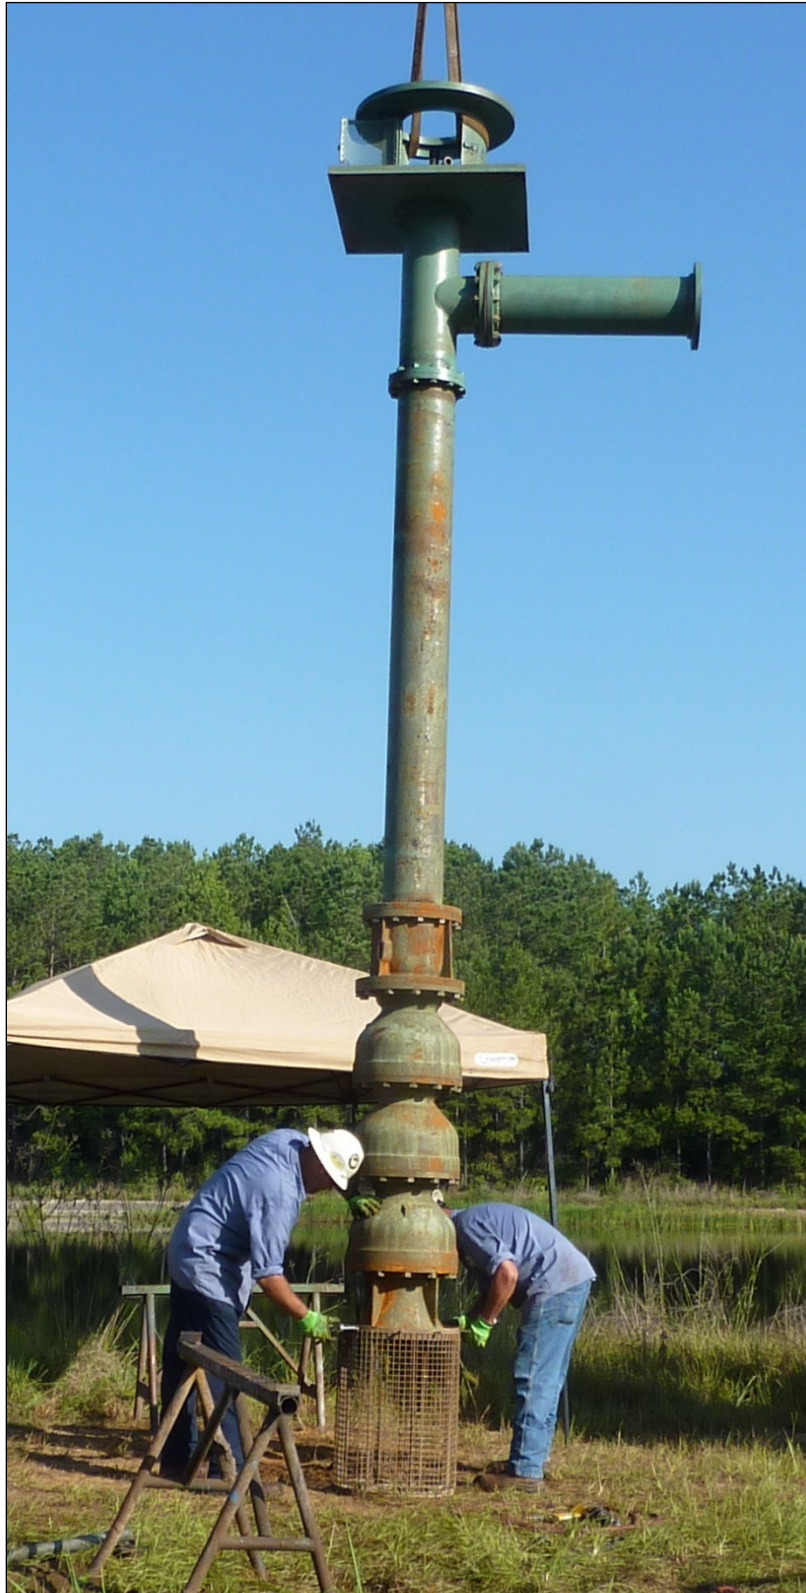
Figure 23. Condition of outer surfaces of Unit 1 pump, after 15 months of service.

Some corrosion was noted in spots on the outer surfaces of the column pipe and the bowls, but it was not uniform over the entire surface. The corrosion did not perforate the material in any places.

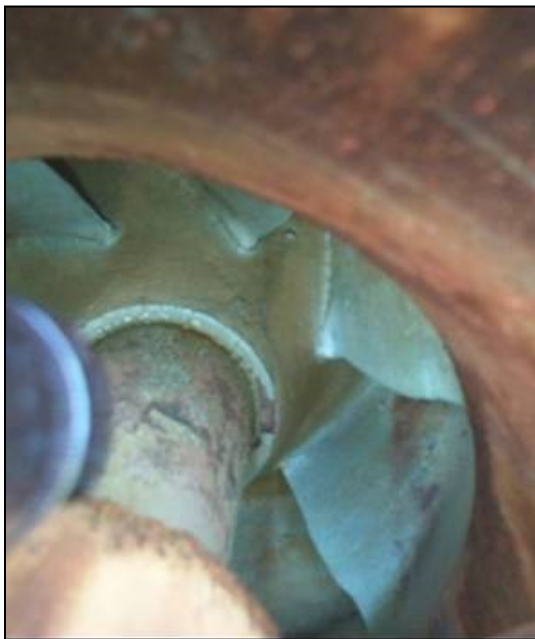
Figure 24. Condition of Unit 1 first-stage impeller, after 15 months of exposure.

The Unit 1 pump was then disassembled. The first-stage impeller had only minimal corrosion and erosion damage, as shown in Figure 24.

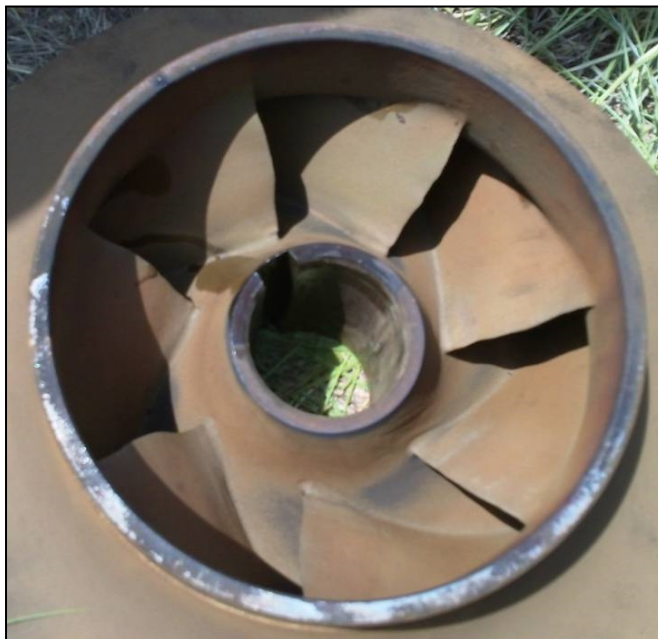
Figure 25. Condition of Unit 1 first-stage impeller after 15 months of exposure.

Upon removing the first-stage impeller from the pump bowl, some minor surface corrosion was evident. This corrosion was minimal, and it was easily wiped off. Minor erosion of the fins at the leading edges was noted, as shown in Figure 25.

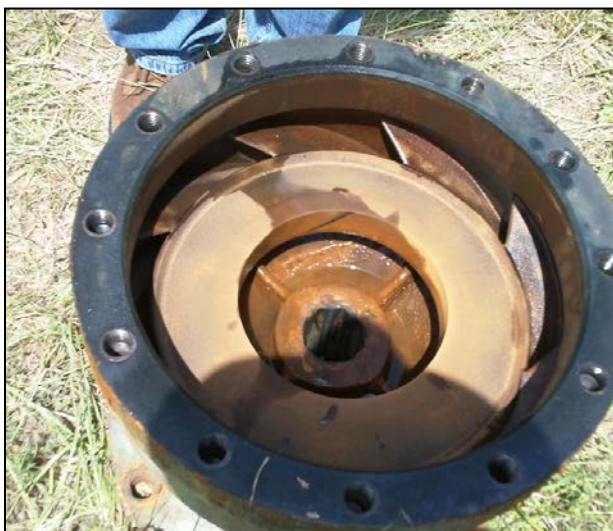
Figure 26. Condition of Unit 1 second stage pump bowl, after 15 months of exposure.

Nearly all of the pump bowl sections had some minor surface corrosion inside, but no wear or erosion damage. The second-stage bowl for Unit 1, after being removed from the pump assembly, is shown in Figure 26.

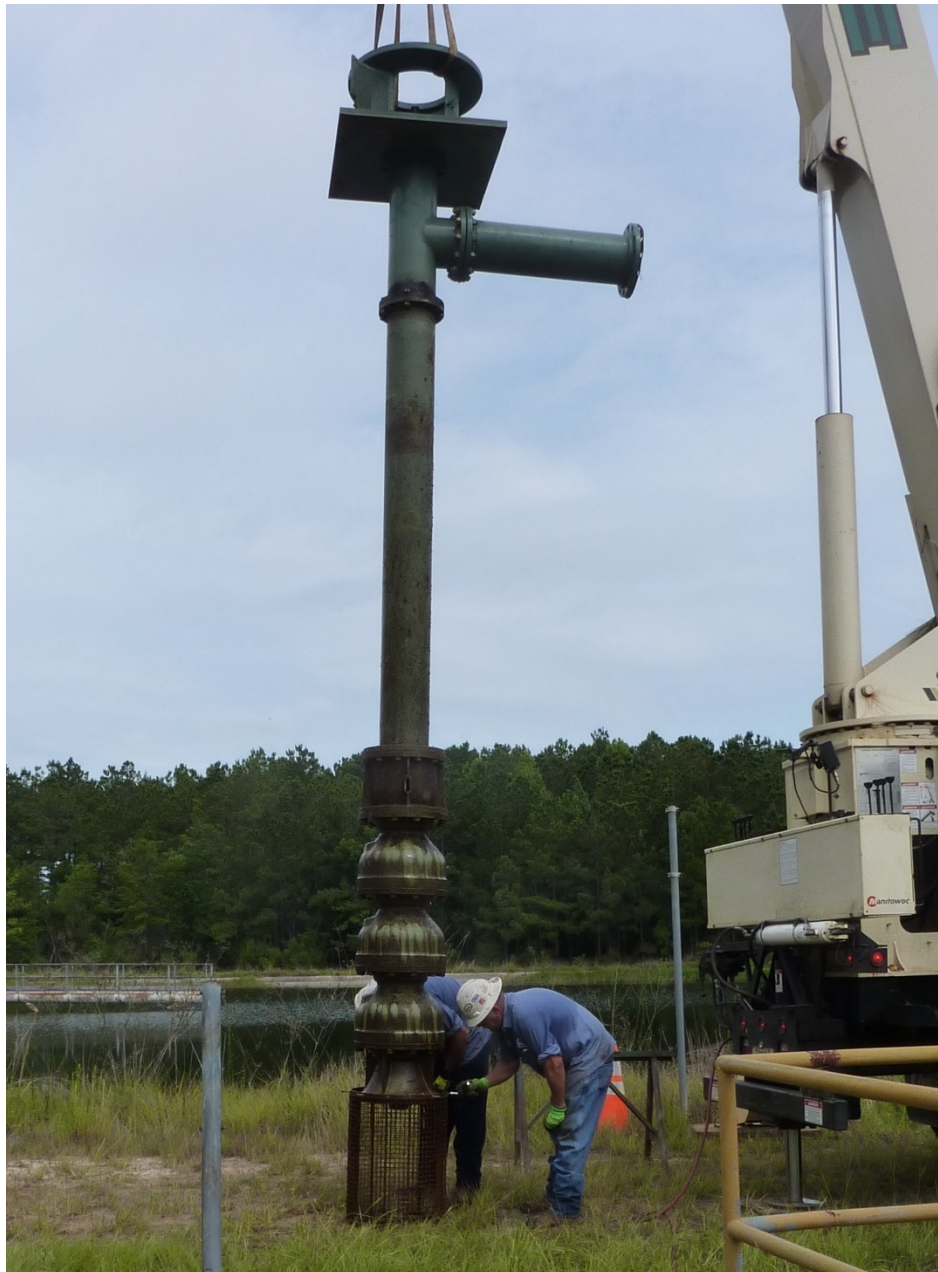
Figure 27. Condition of outer surfaces of Unit 2 pump after 15 months of service.

Some spot corrosion was noted on the outer surfaces of the column pipe and the bowls. The corrosion did not perforate the material.

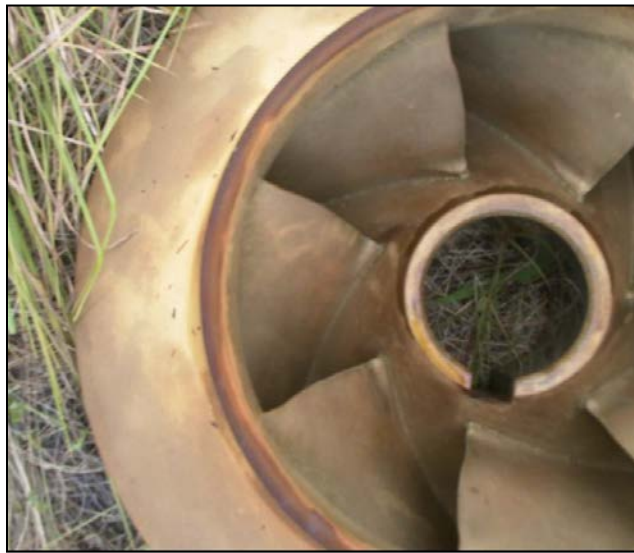
The Unit 2 pump was disassembled and inspected. Like the Unit 1 pump components, the Unit 2 pump components had minor surface corrosion. The corrosion was minimal and easily wiped off. The third-stage impeller exhibited minor uniform corrosion. Upon removing this impeller, very minor wear on the leading edges was noted, as shown in Figure 28.

Figure 28. Condition of Unit 2 third-stage impeller after 15 months of exposure, showing minor wear on leading edges.

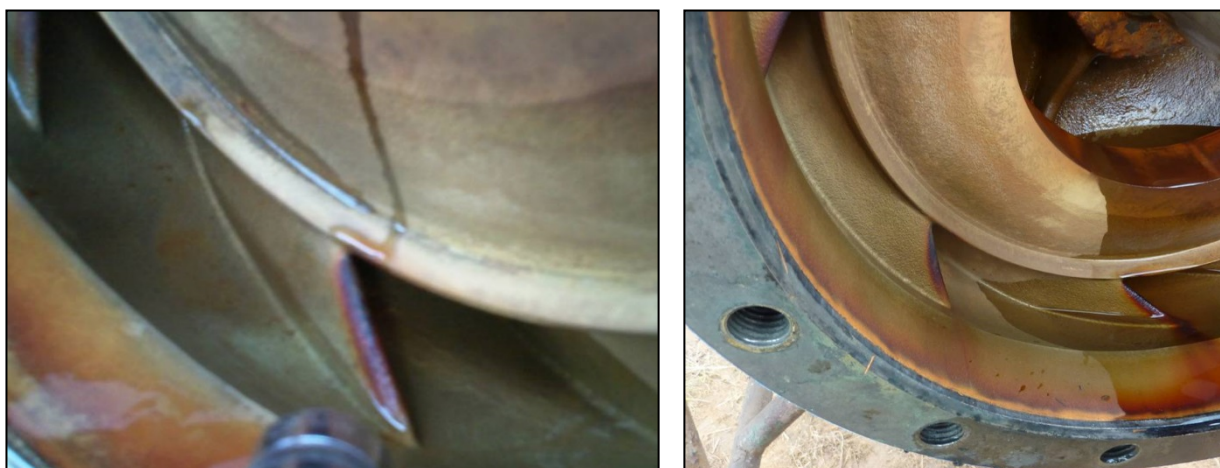
The condition of the Unit 2 pump components (EN coated) was slightly different from the condition of Unit 1 pump components (Stellite coated). In Unit 2, the edges of all bowl vanes showed dark staining, as seen in Figure 29.

Figure 29. Condition of Unit 2 first-stage bowl (left) and second-stage bowl (right) after 15 months of exposure, showing dark stains on vanes.

One hypothesis is that these areas might be surfaces where the thermal spray process did not fully coat the steel. Thermal spray application is inherently a line-of-sight process, and can be difficult to apply uniformly or completely to uneven or partially concealed surfaces. This hypothesis is circumstantially supported by comparison with the EN coating process, which involves full immersion in chemicals and coats all surfaces evenly; no similar dark spots were observed on Unit 1 pump components.

Another possible explanation for the dark spots is iron deposits, caused by sediment that slowly dripped down the submerged pump. It was noted that iron and other sedimentary material were present on all pump components.
